Ohio Gas Association 2011 Technical Seminar

Lessons Learned From Liability Insurance Claims Paid

Ron Six, Instructor
Senior Utility Consultant
AEGIS Insurance Services, Inc.

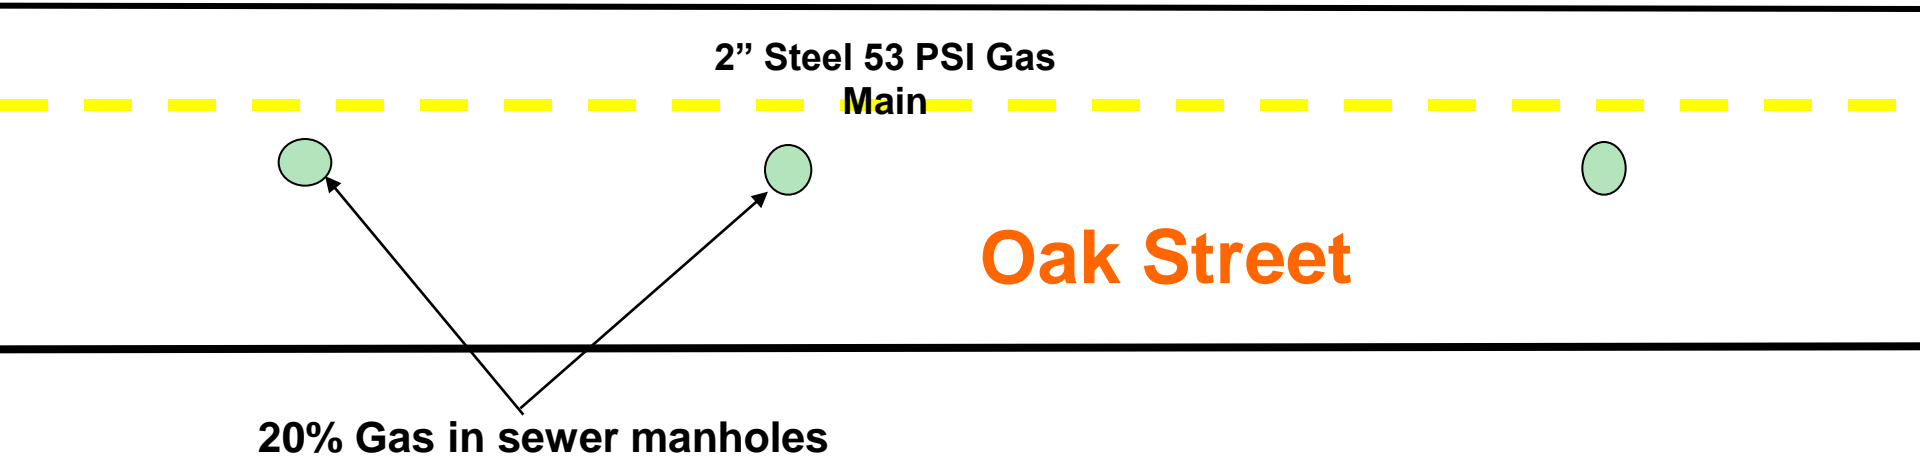
20% Gas In Sewer Manhole

First Responder smells a very strong odor of gas in the area as he arrives (4:05 pm). Checks sewer manholes in the street and finds 20% gas in each manhole. Calls for a crew.

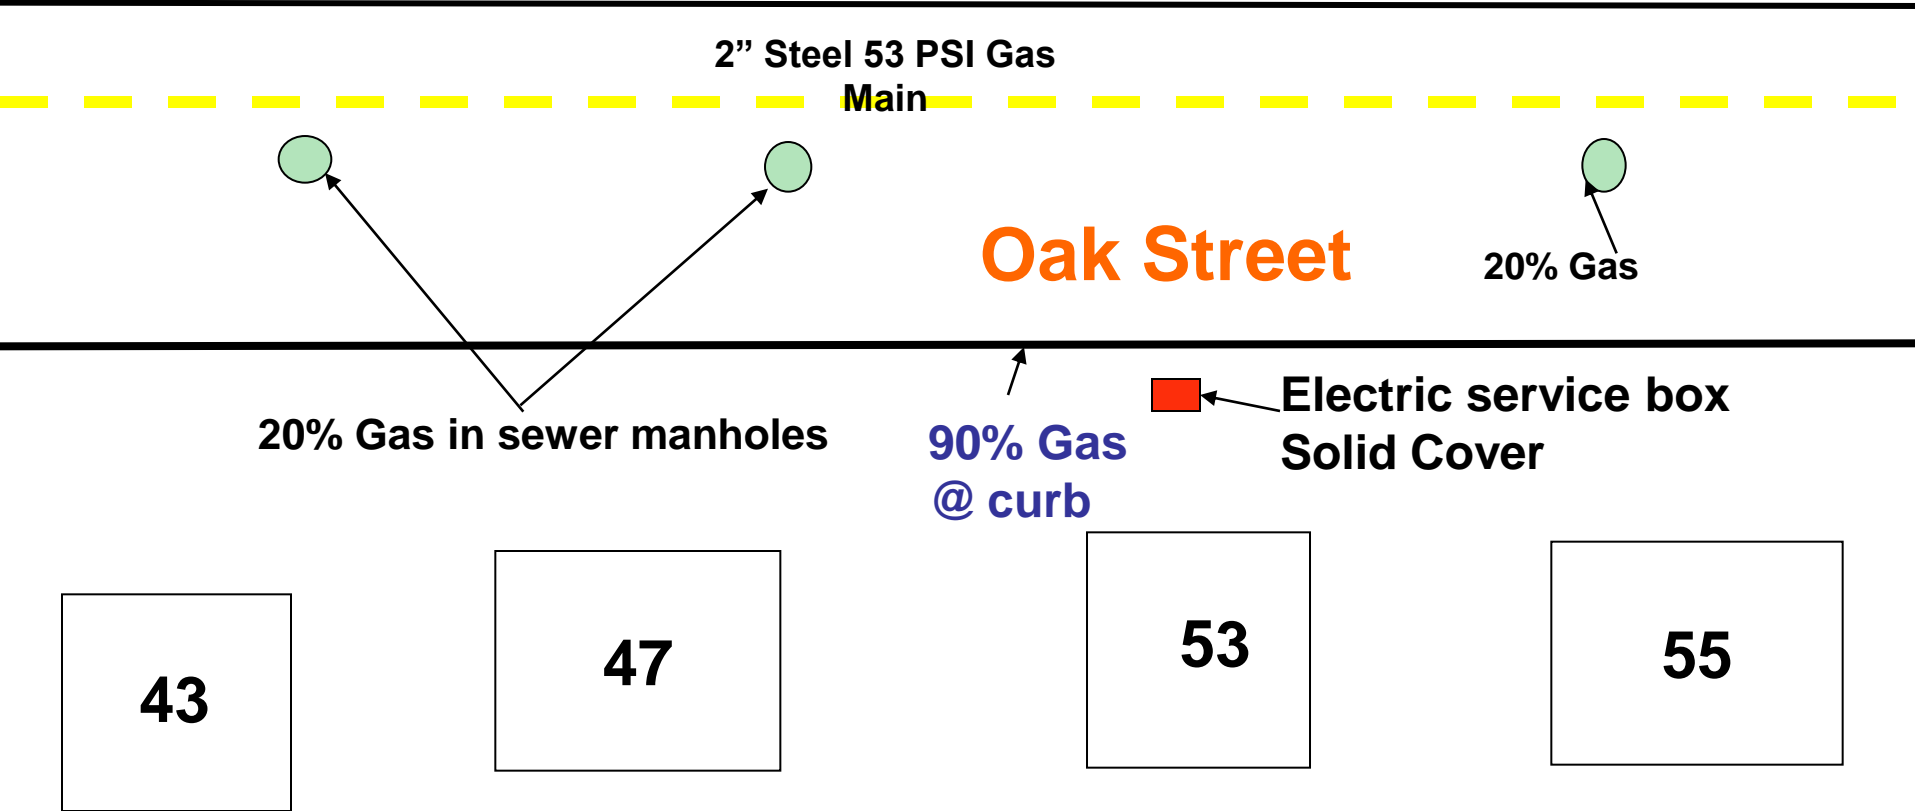
Checks inside #46 and finds 0% gas in atmosphere, but gets a 10% gas reading at electric service entrance to building in the basement. Starts taking additional readings outside.

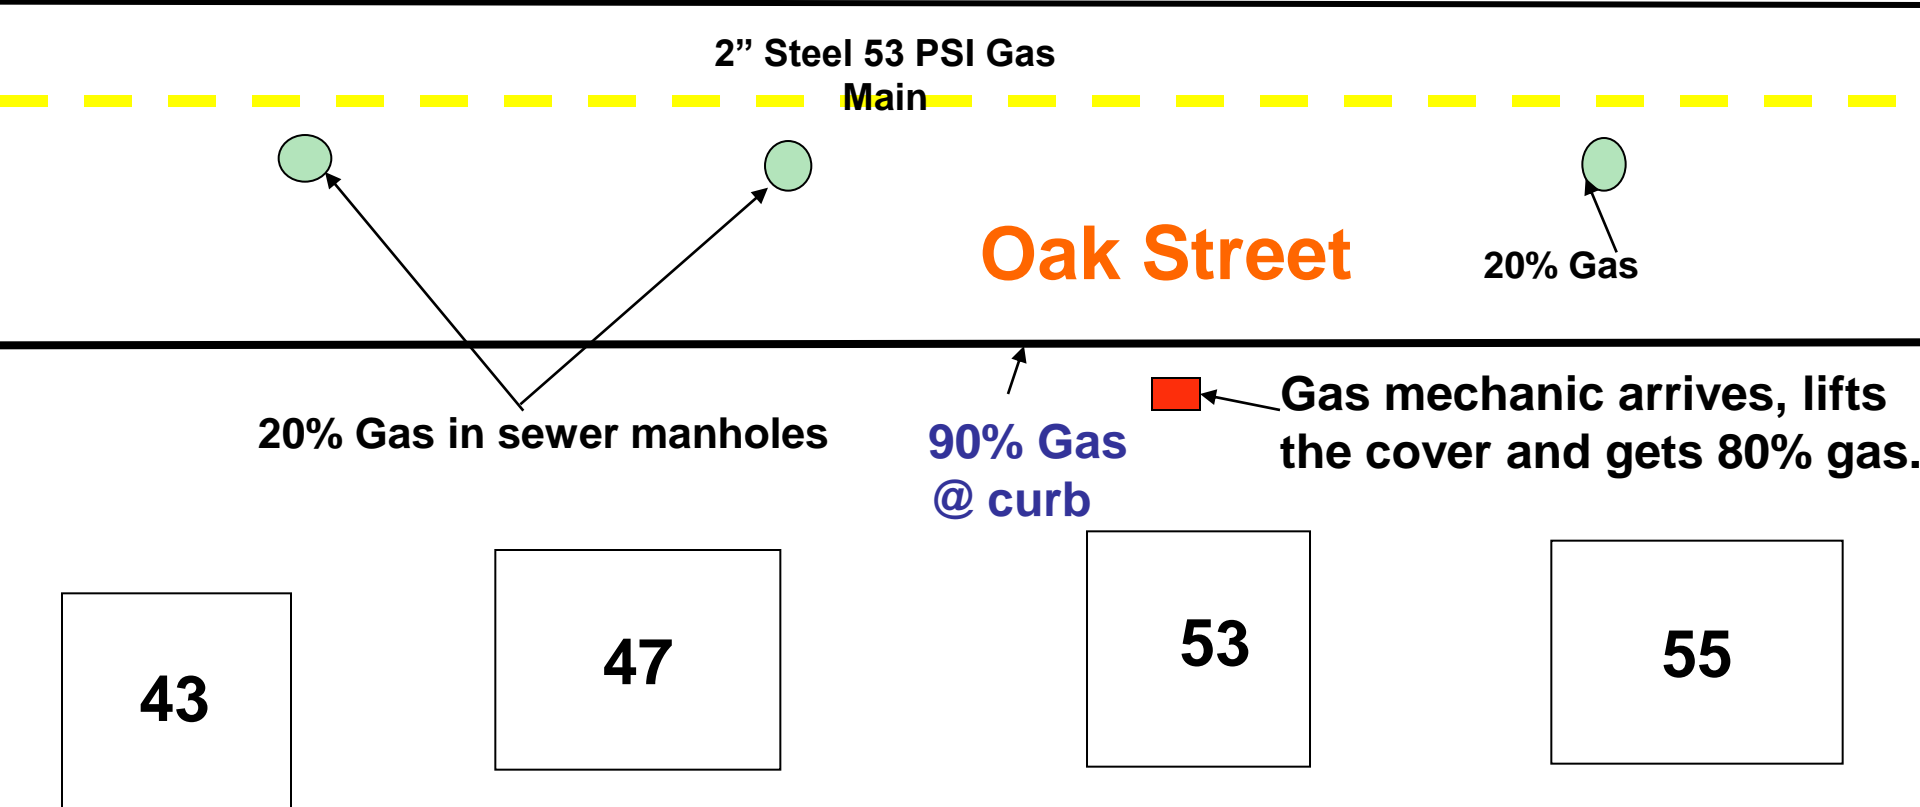
Gas mechanics arrive and they lift the cover on the electric service box and They get a 80% gas in air reading.

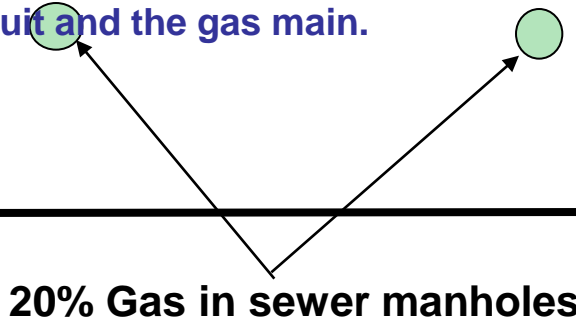
Explosion at #50 occurs at 4:50pm

Explosion occurs at 4:50pm, a forty year old woman was killed others injured.

Cause of the leak attributed to a short in electric service cables caused current to flow onto the steel gas main where they crossed. Arcing created holes in both the electric conduit and the gas main.

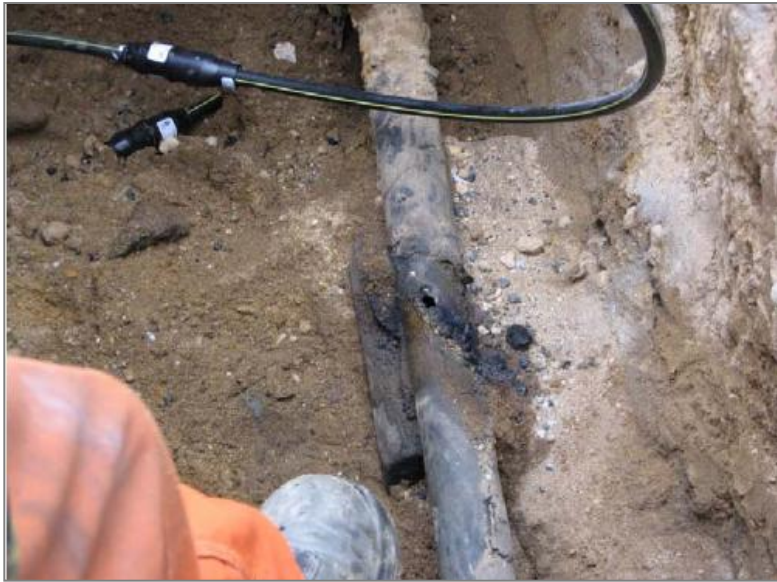
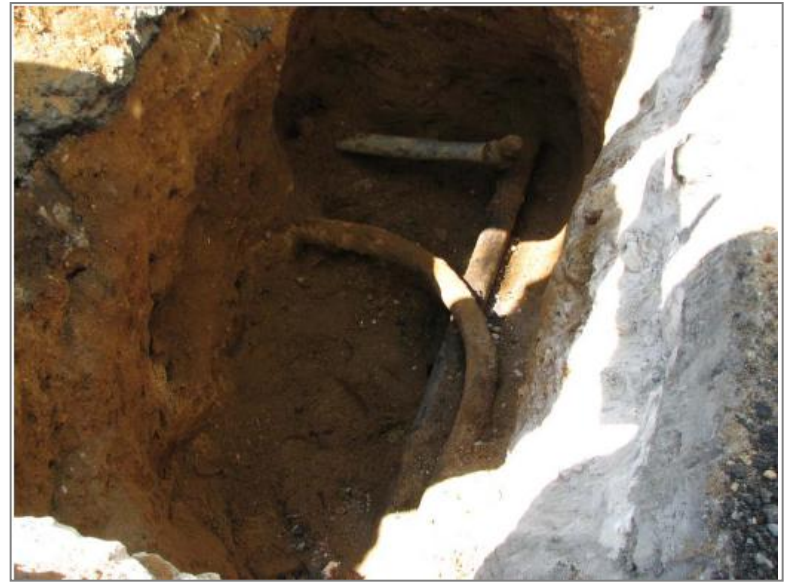
Hole Made When Shorted Electric Cable Arced Over To Gas Main

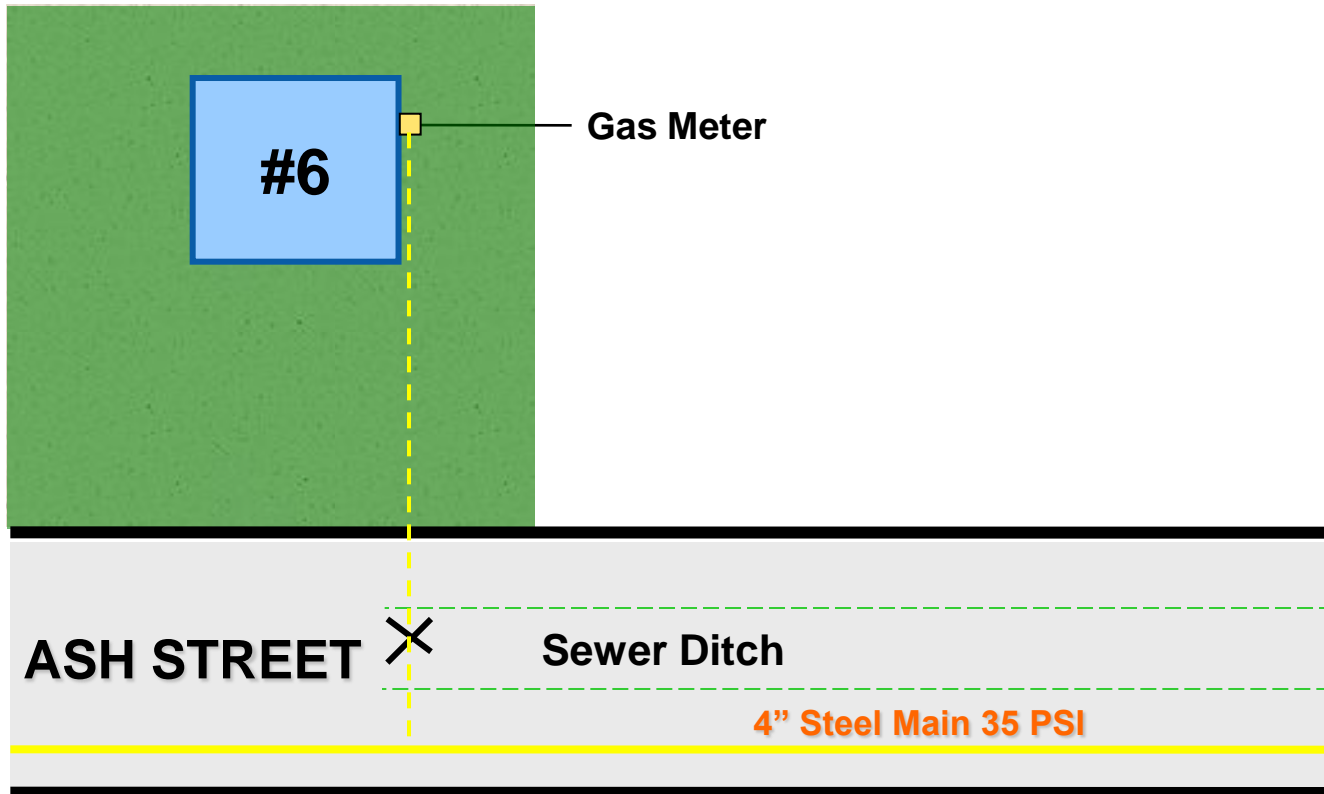
Figure # 1

A contractor has snagged the 1" steel service and bowed it in the ditch. A small hole was made in the line and gas is blowing in the ditch.

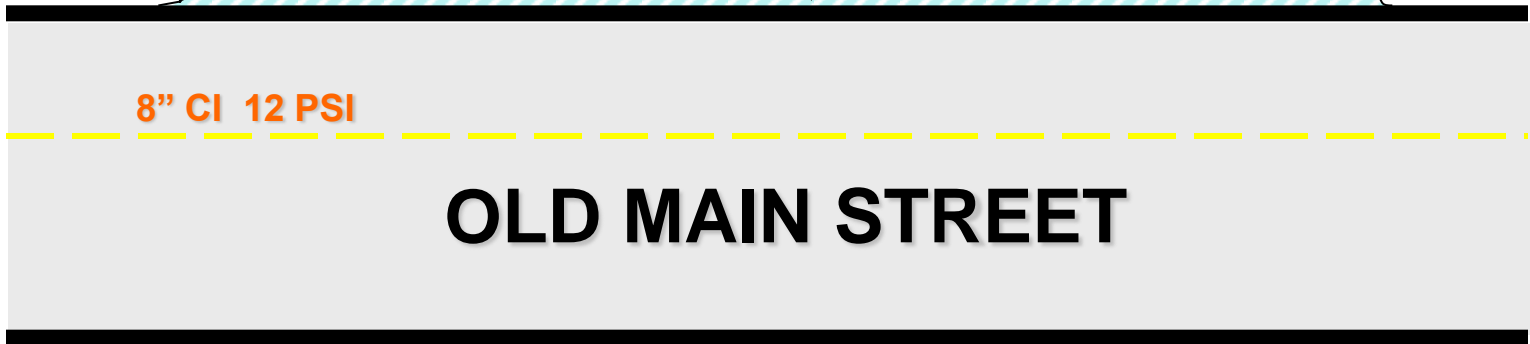
**70% Gas in the atmosphere
Inside of the building.**

**90% Gas @
Foundation Wall**

**100% Gas @
Curb**

- Fire department and gas company are on the scene.
- Buildings have been evacuated.
- 70% gas/air in atmosphere in 402.
 - a. **Pinpoint the leak**
 - b. **Eliminate Ignition Sources**
 - c. **Ventilate the Building**
 - d. **All of the Above**
