Ohio Gas Association 2011 Technical Seminar

Lessons Learned From Liability Insurance Claims Paid

Ron Six, Instructor
Senior Utility Consultant
AEGIS Insurance Services, Inc.

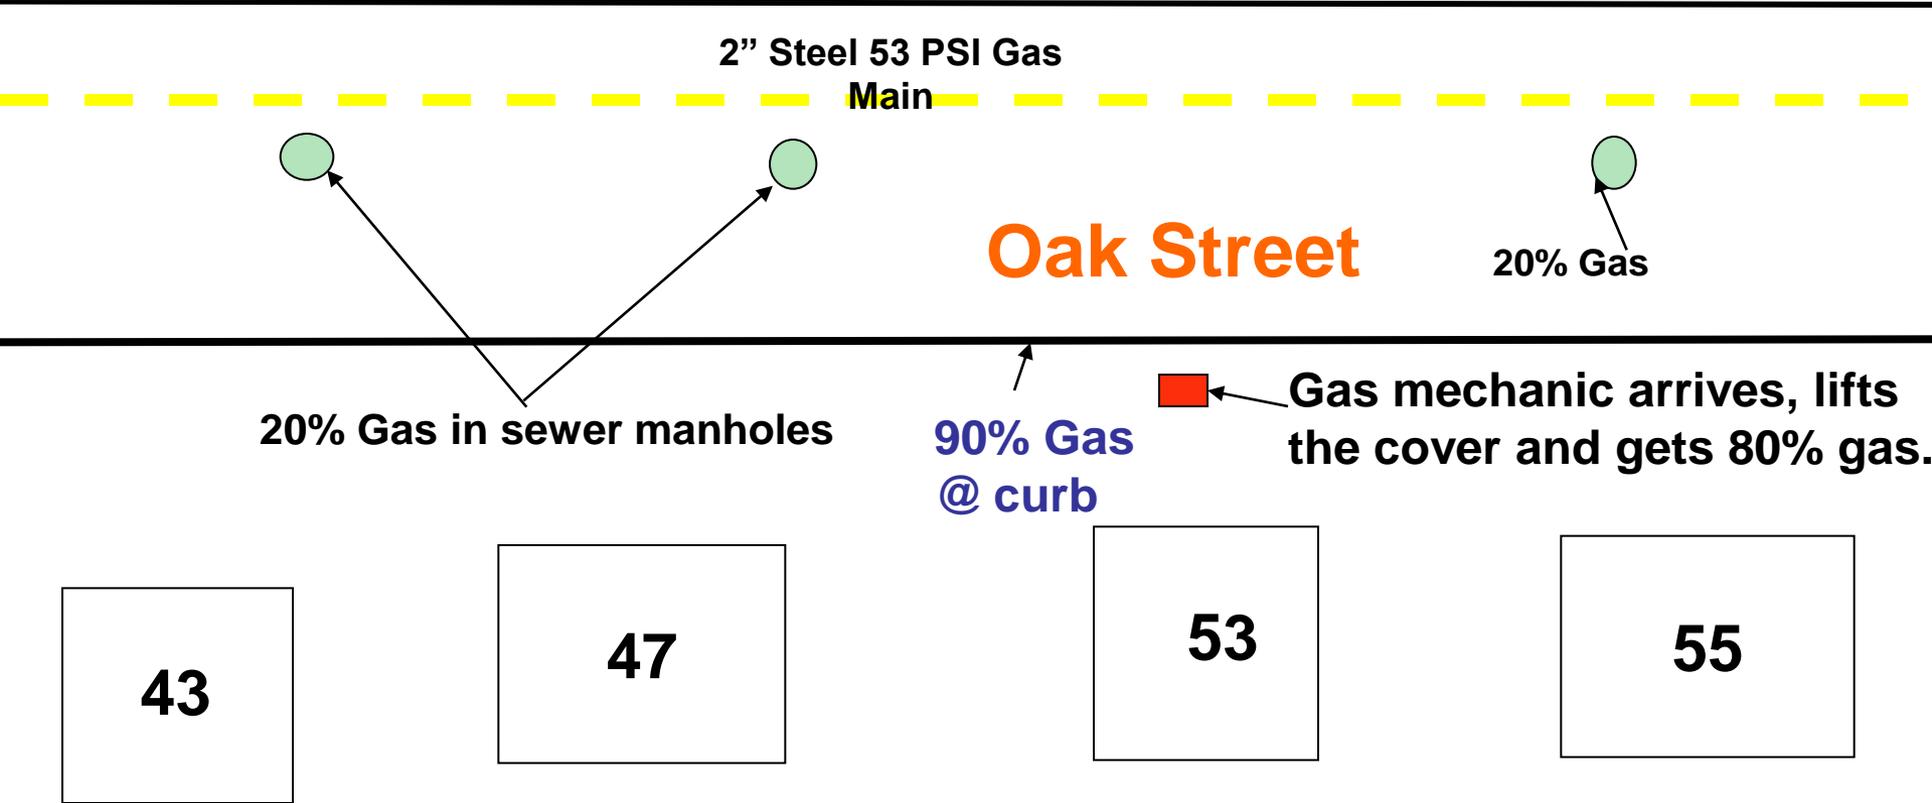
Gas mechanics arrive and they lift the cover on the electric service box and They get a 80% gas in air reading.

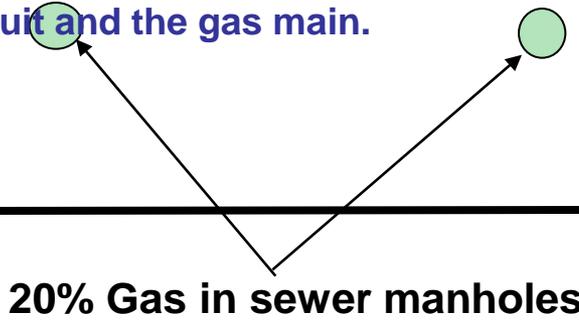
Explosion at #50 occurs at 4:50pm

Explosion occurs at 4:50pm, a forty year old woman was killed others injured.

Cause of the leak attributed to a short in electric service cables caused current to flow onto the steel gas main where they crossed. Arcing created holes in both the electric conduit and the gas main.

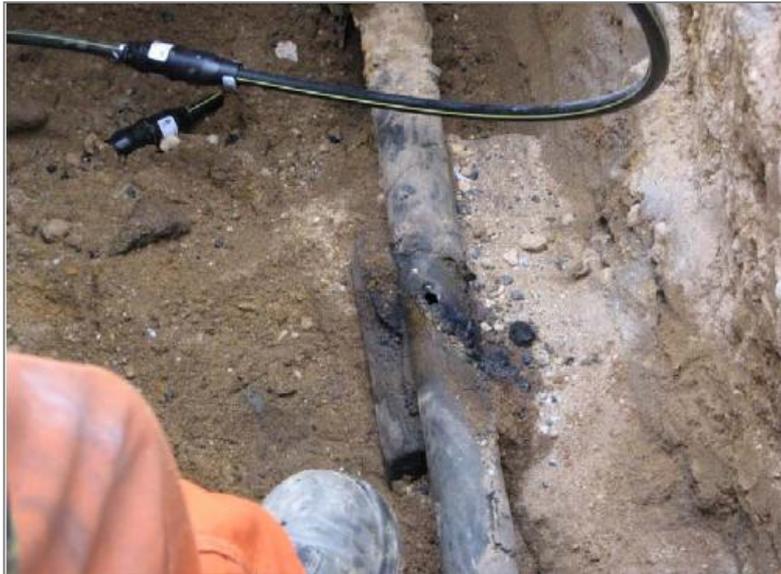
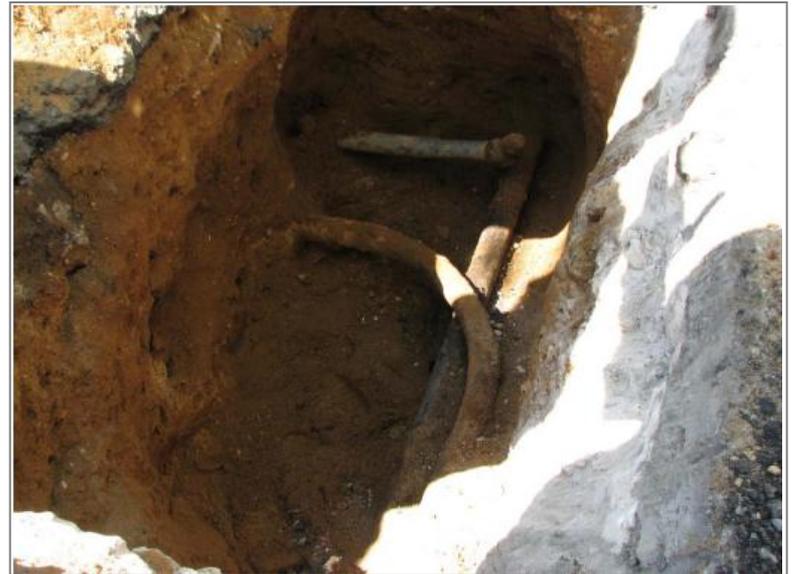
Hole Made When Shorted Electric Cable Arced Over To Gas Main

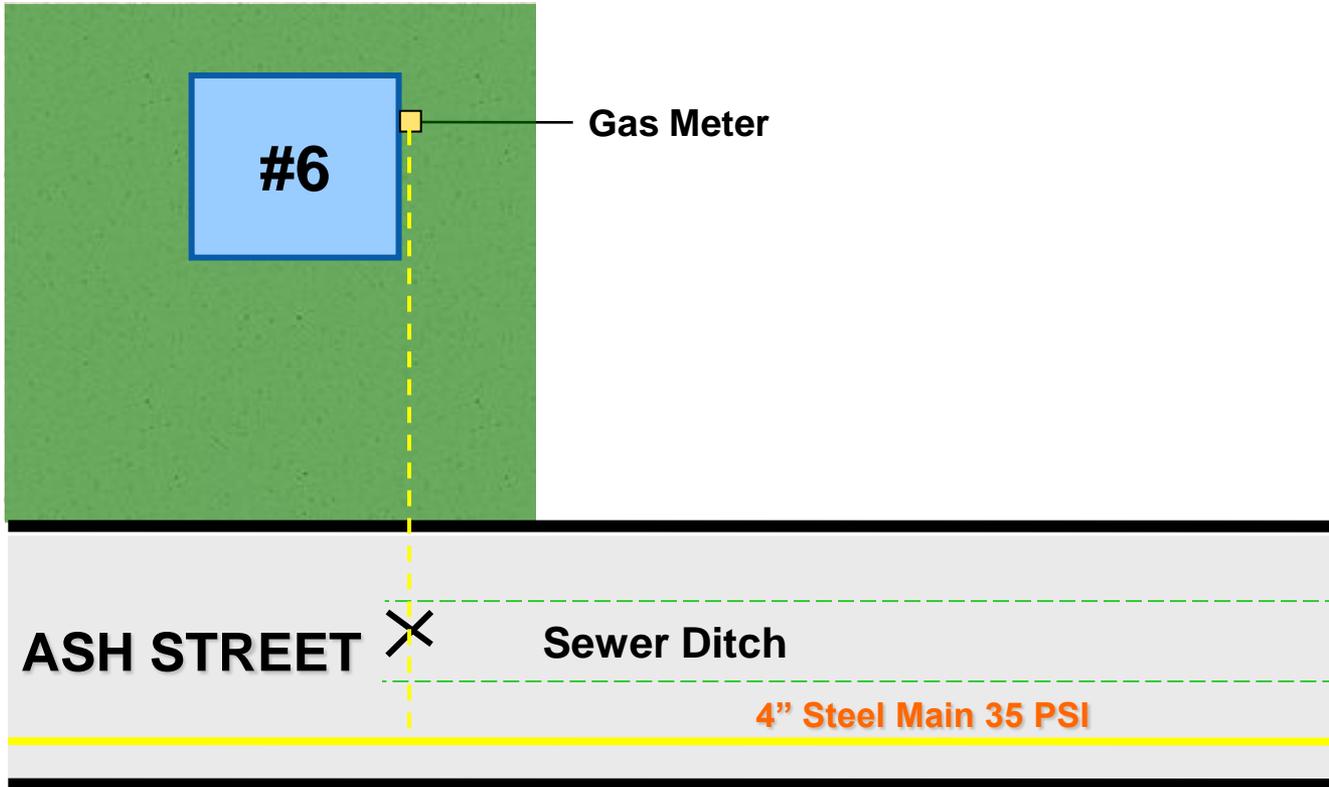
Figure # 1

A contractor has snagged the 1" steel service and bowed it in the ditch. A small hole was made in the line and gas is blowing in the ditch.

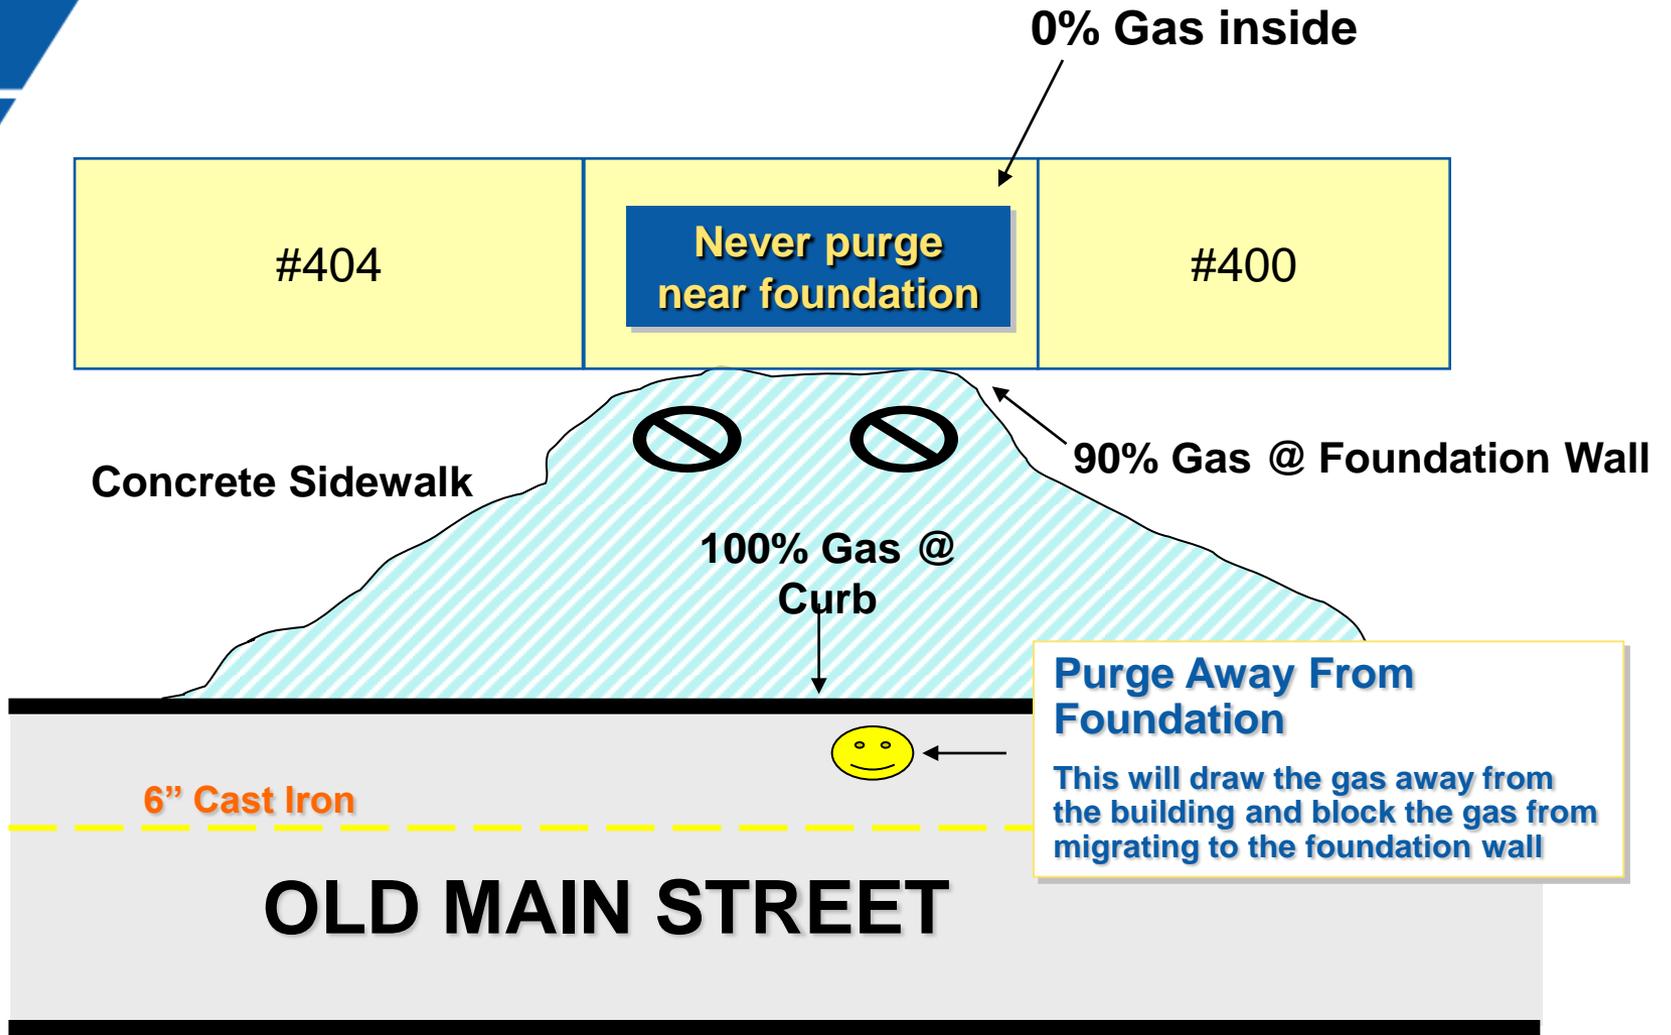
0% Gas inside

90% Gas @ Foundation Wall

100% Gas @
Curb

**Never purge
near foundation**

**Purge Away From
Foundation**
This will draw the gas away from
the building and block the gas from
migrating to the foundation wall
