Residential Methane Det

Ohio Gas Association Technical Seminar 2023

Gas Emergency Response Center

Con Edison Company of New York

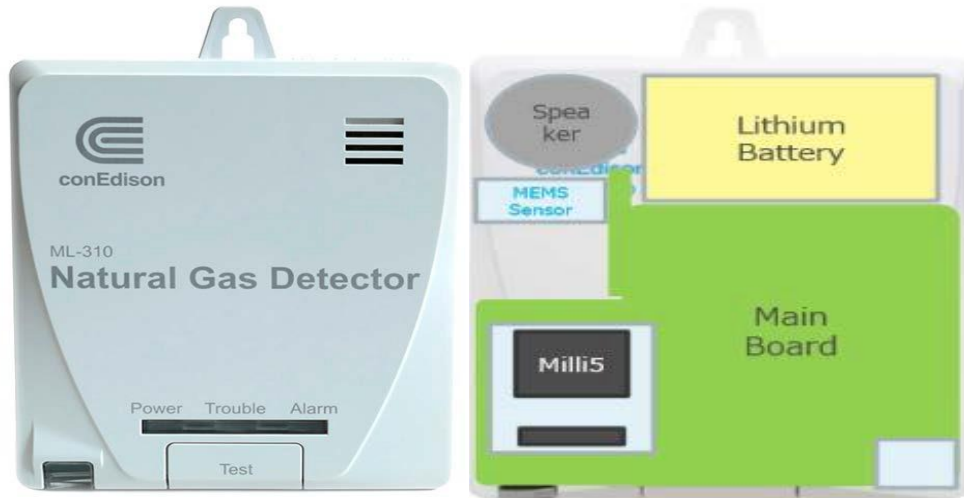
Internal components

The system makes natural gas detection in buildings very reliable and facilitates response within minutes.

- UL and FCC certified
- Technology improvements will extend battery and sensor life from five to ten years by 2023
- Has local audible alarm and communicates through AMI network:
 - Detects and alarms for gas levels at 10% of lower explosive limit (very sensitive) and provides continuous messaging
 - Reports heartbeat (every 8 hours)
 - Reports warnings for low battery and sensor issues
- No customer maintenance required

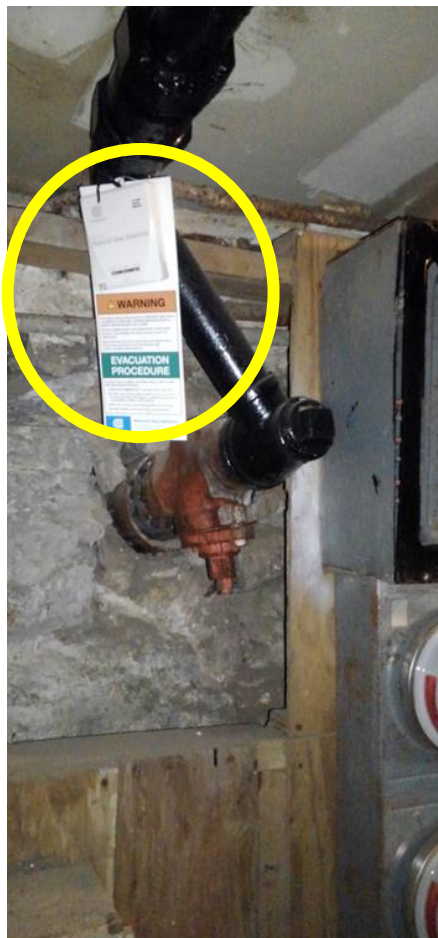
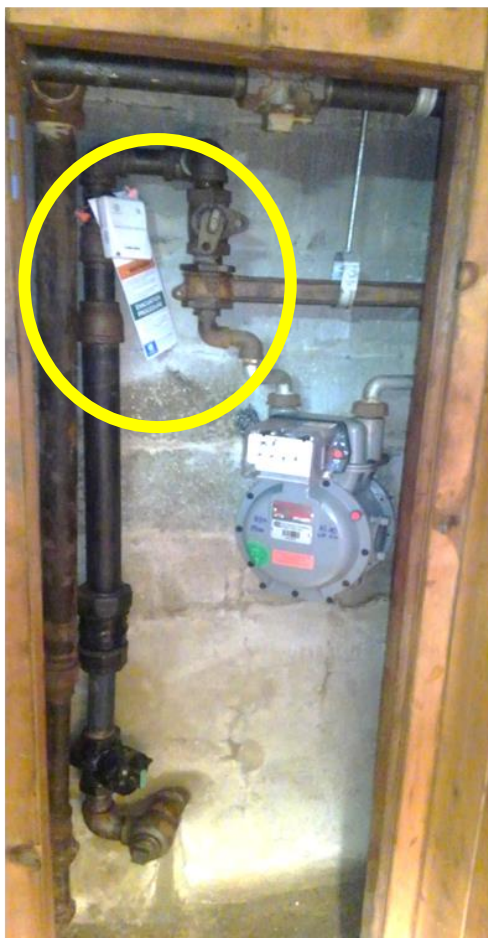
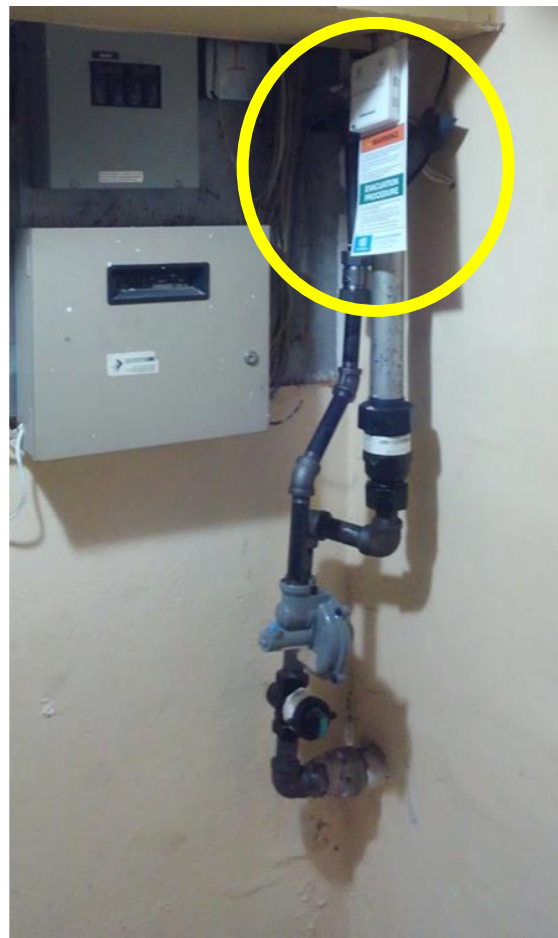
Examples - Installation Locations

- AMI enabled Natural Gas Detectors (NGDs) are installed inside buildings near the gas service point of entry and provide real time monitoring and alarms for natural gas (methane) leaks.
- Sensor and communication technology has enabled major safety risk mitigation for response to natural gas leaks.
- NGD's are a 'first of their kind' device in the United States, a game changer in the industry for public safety and are strongly supported by our regulators and municipal fire departments.
- Gas leak alarm results have been accurate and reliable, initiating prompt response from our first responders and fire department personnel to mitigate potentially dangerous conditions.
- Technology improvements will extend battery and sensor life from five to ten years by 2023, reducing replacement activity.

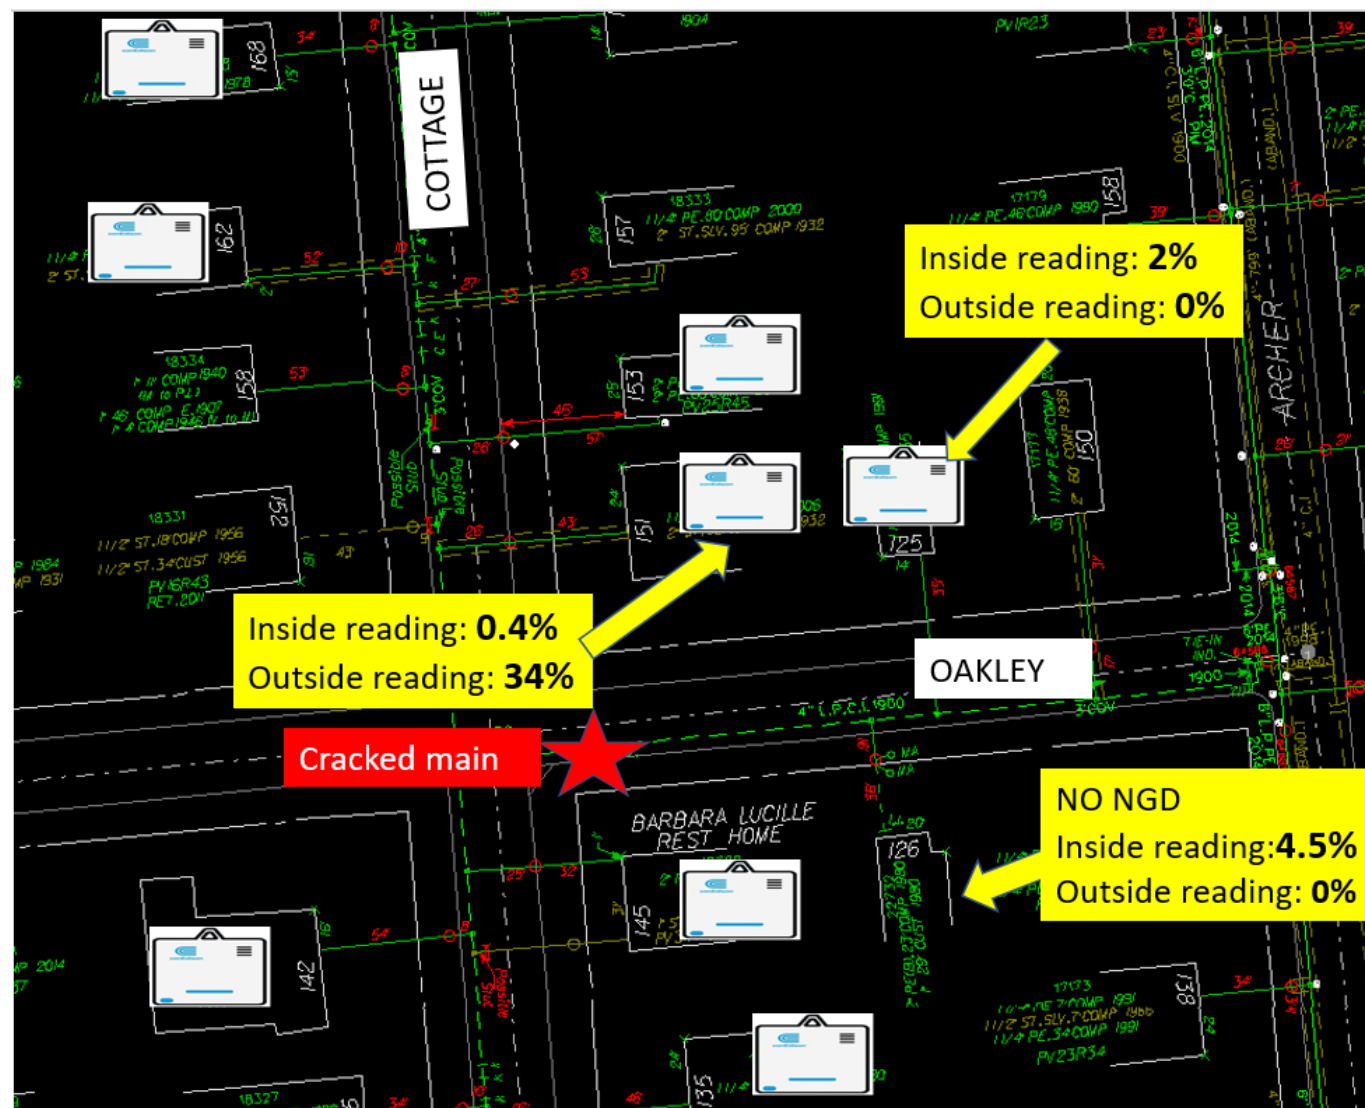
Outside Leak from Cracked CI Main

- Two detectors alarmed during a cracked cast iron gas main leak

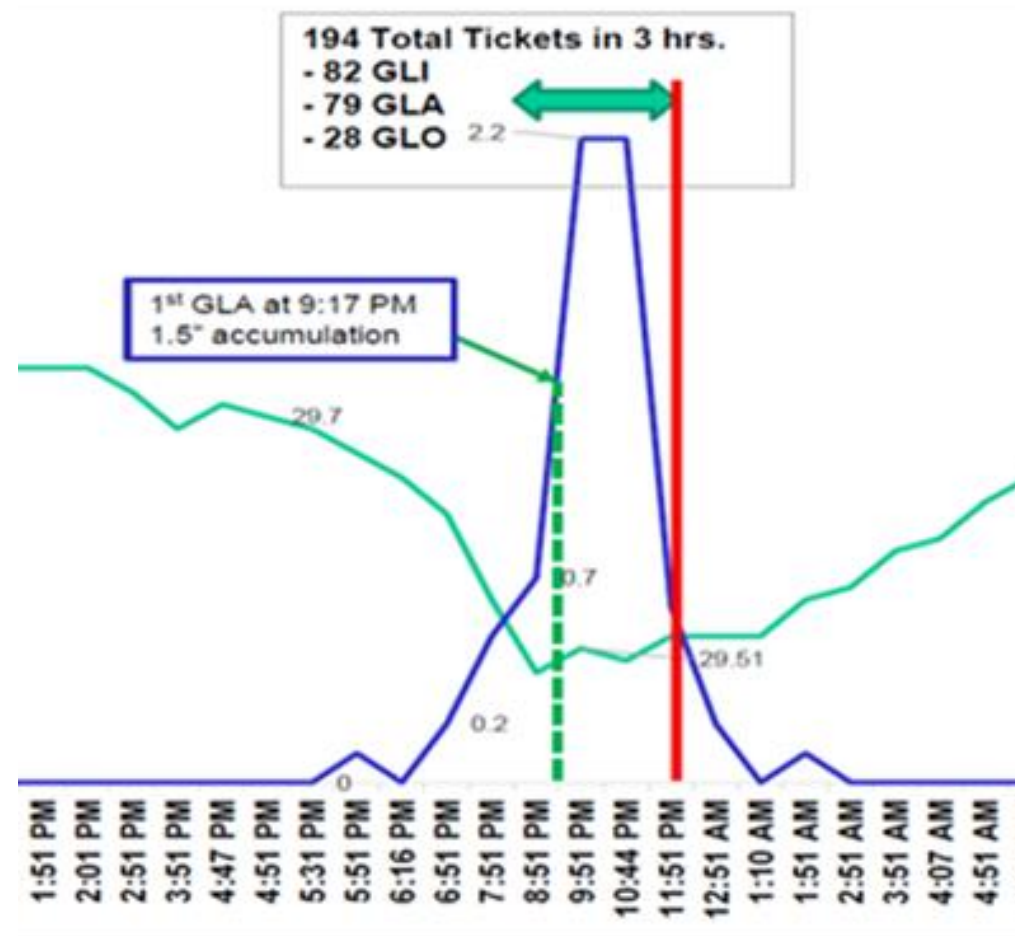
Precipitation and Barometric Pressure

- Carbon monoxide from building fires
- Illegal pipework
- Flooding
- Elevated GLA activity during heavy rains
