Ohio Gas Association 2011 Technical Seminar

Lessons Learned From Liability Insurance Claims Paid

Ron Six, Instructor
Senior Utility Consultant
AEGIS Insurance Services, Inc.

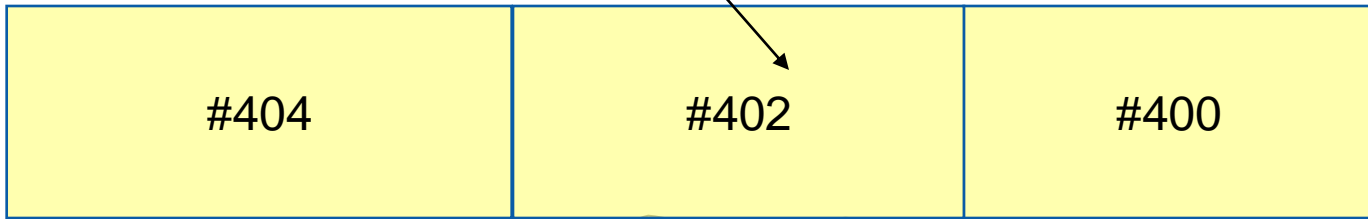
**70% Gas in the atmosphere
Inside of the building.**

**90% Gas @
Foundation Wall**
