Ohio Gas Association 2011 Technical Seminar

Lessons Learned From Liability Insurance Claims Paid

Ron Six, Instructor
Senior Utility Consultant
AEGIS Insurance Services, Inc.

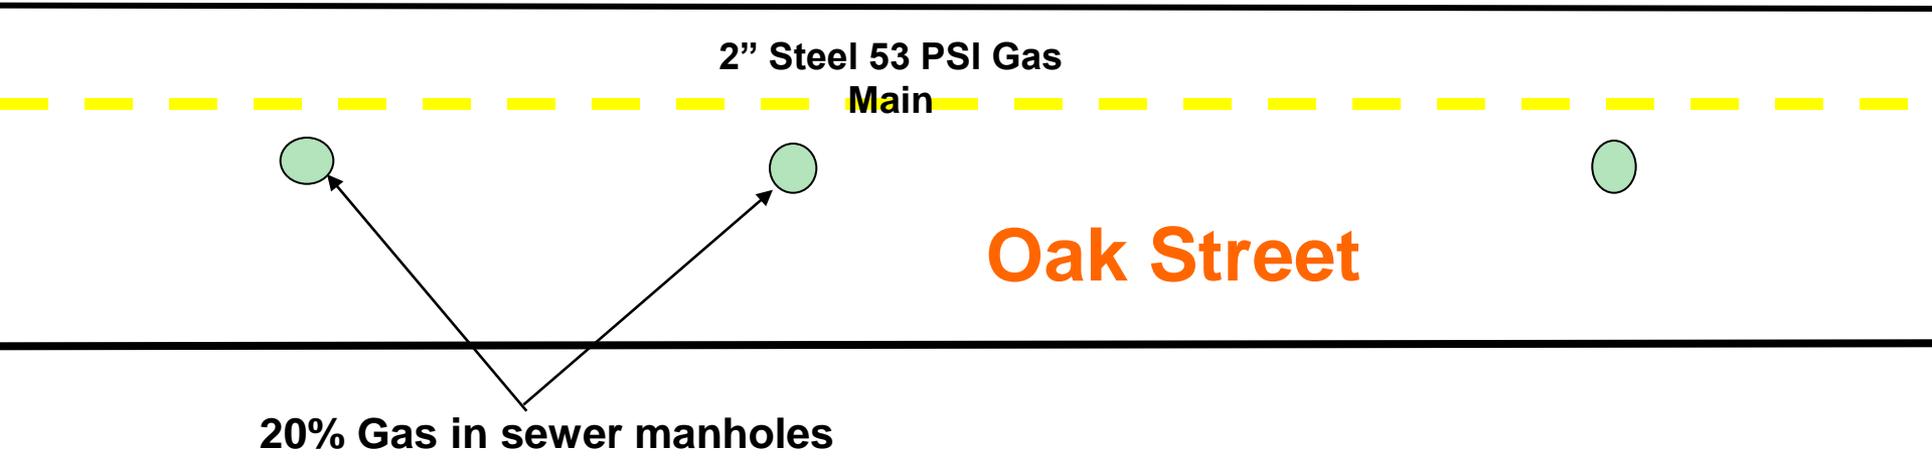
First Responder smells a very strong odor of gas in the area as he arrives (4:05 pm). Checks sewer manholes in the street and finds 20% gas in each manhole. Calls for a crew.

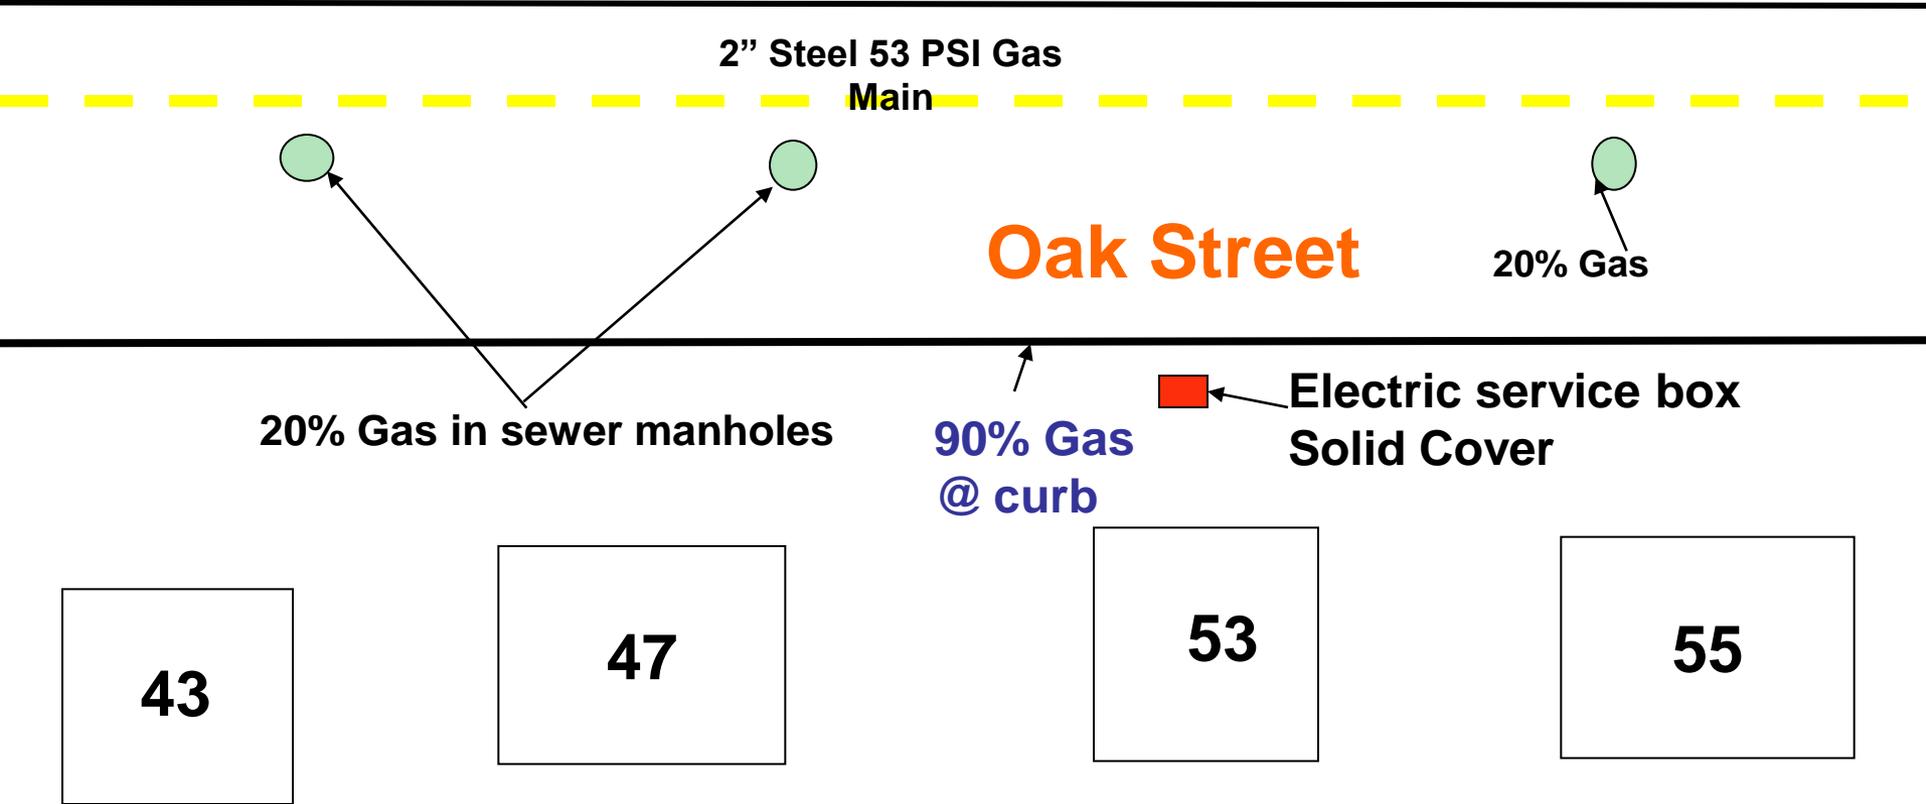
Checks inside #46 and finds 0% gas in atmosphere, but gets a 10% gas reading at electric service entrance to building in the basement. Starts taking additional readings outside.

Gas mechanics arrive and they lift the cover on the electric service box and They get a 80% gas in air reading.

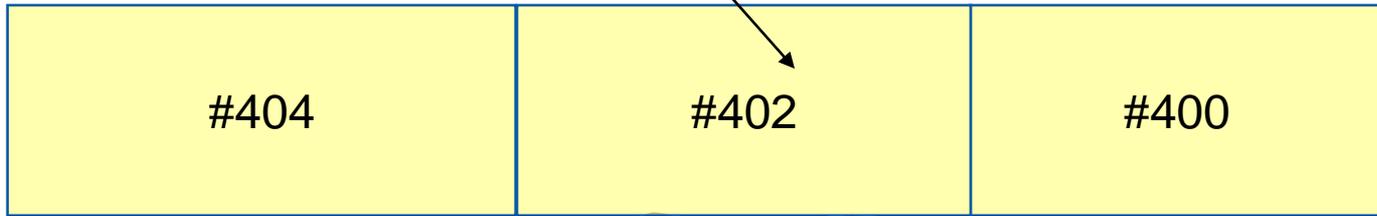
**70% Gas in the atmosphere
Inside of the building.**

**90% Gas @
Foundation Wall**

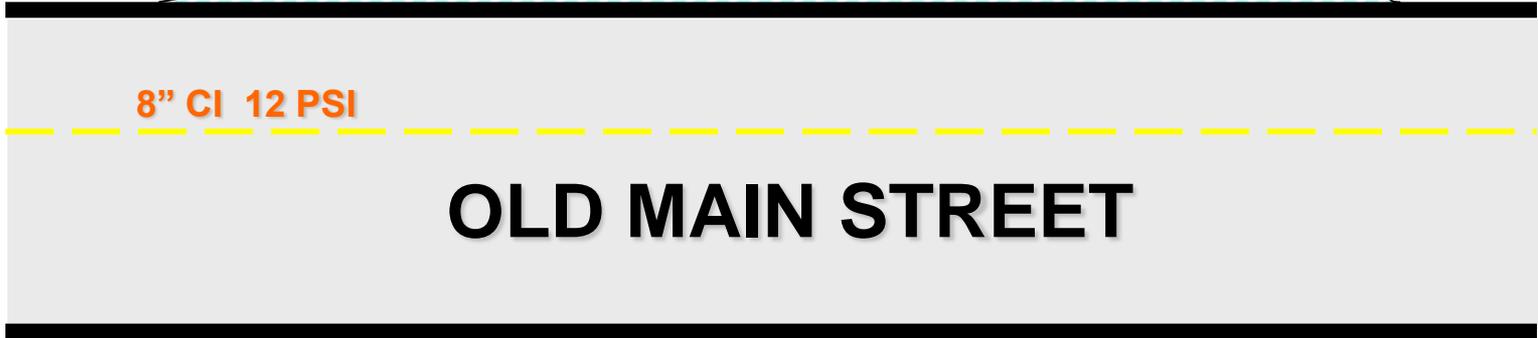
8" CI 12 PSI

OLD MAIN STREET

- Fire department and gas company are on the scene.
- Buildings have been evacuated.
- 70% gas/air in atmosphere in 402.
 - a. **Pinpoint the leak**
 - b. **Eliminate Ignition Sources**
 - c. **Ventilate the Building**
 - d. **All of the Above**

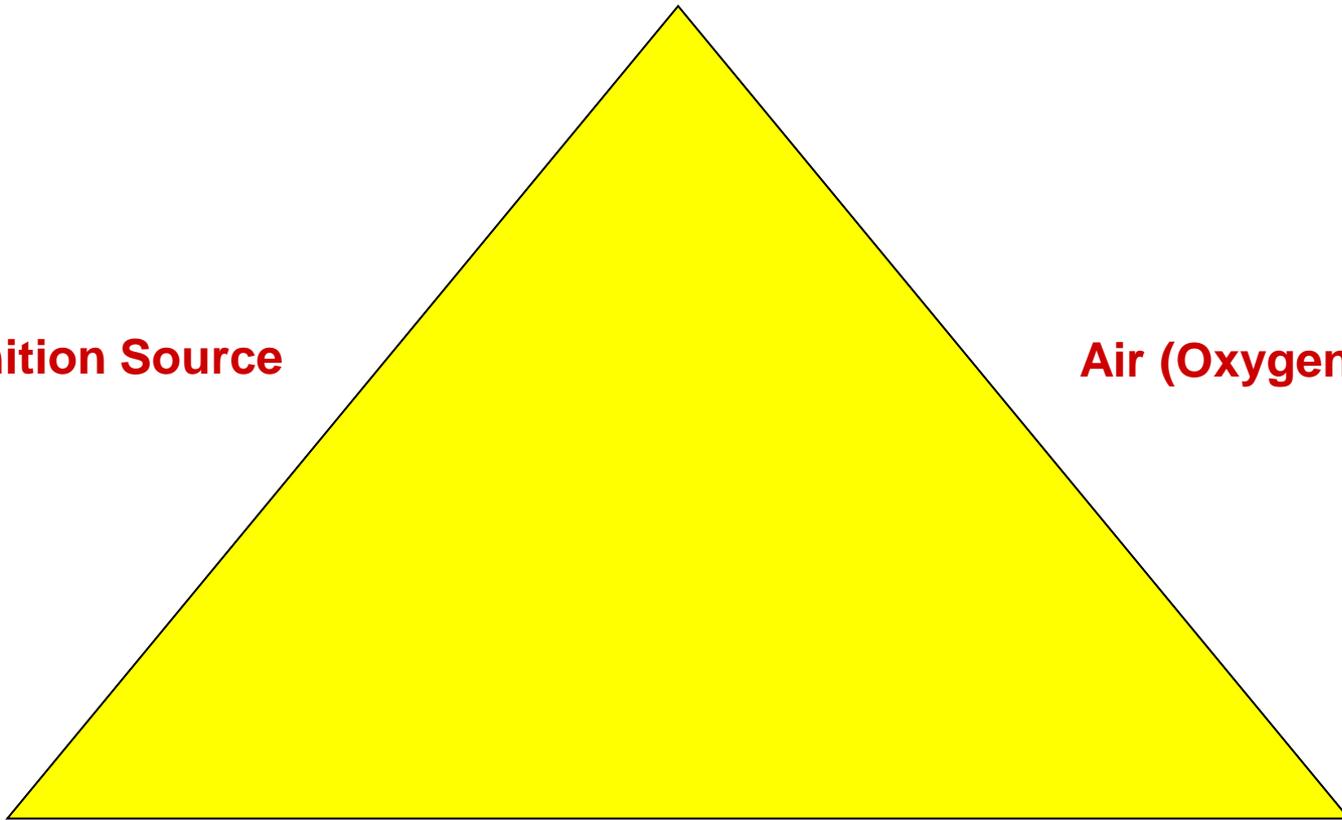
Gas Concentrations between 5.0% – 15.0% Gas/Air

In order to have an ignition you need 3 things:

- **Gas concentrations between 5-15%**
- **A competent ignition source**
- **Air**

If we can eliminate one of the above we can prevent the ignition. Eliminating the ignition sources and passive ventilation may be the safest way of handling an emergency of this type. If the ignition occurs, so be it, you have performed your most important job which is **PUBLIC & PERSONAL SAFETY.**
